**A study on how sea defence strategies alter the response of the coast to variations in sea level by monitoring shoreline evolution**

A Dissertation

School of Geography, Environmental  
and Marine Sciences

Ulster University

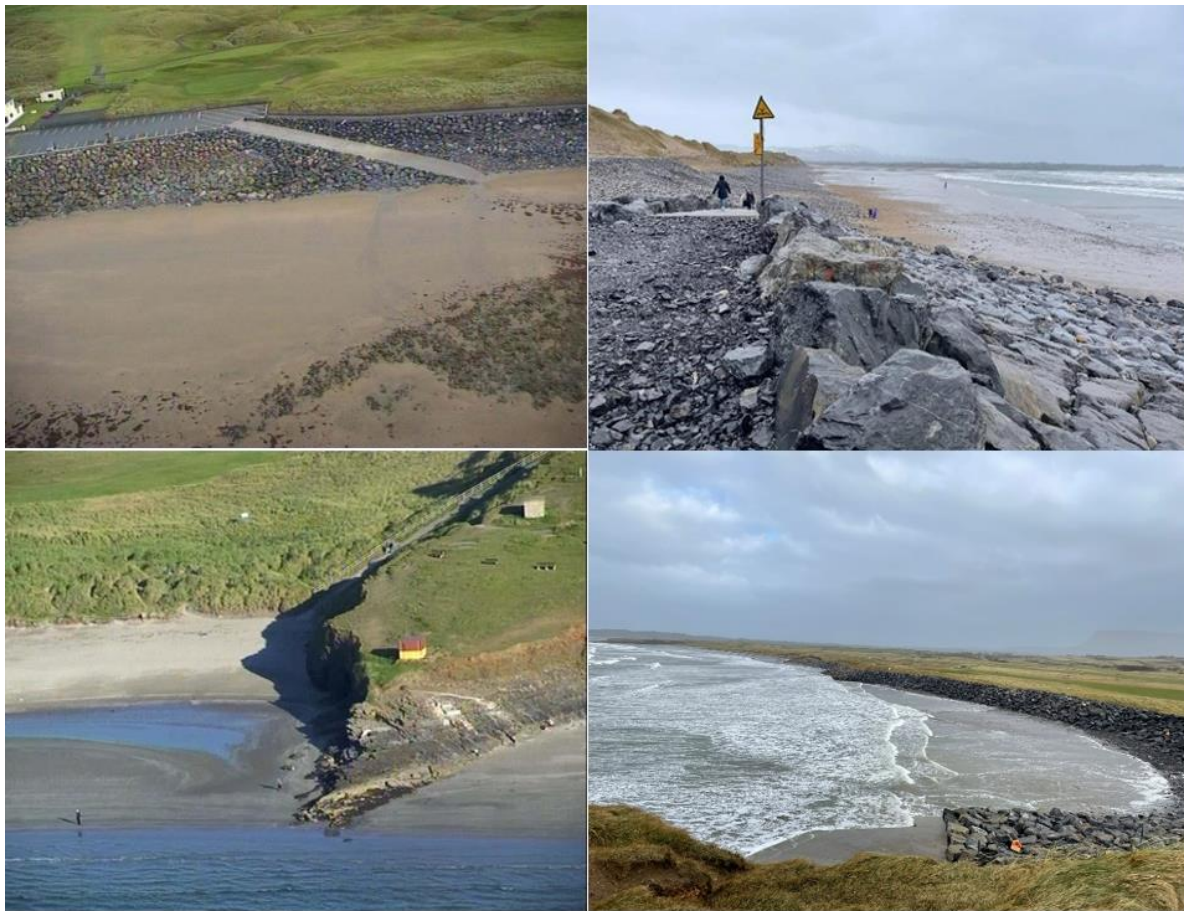
Figure 3 shows the coastal defences installed at the two sites in 2003 and as of 2022. The top left image shows the concrete ramp access to Strandhill beach and the rock armouring which at this time extended 310m from the town towards the sand spit (figure 2). The ground photography image in the top right of figure 3 shows Strandhill at low tide on the 19th of February 2022 at 14:45. The bottom left image shows the access ramp at Rosses Point beach in 2003 previous to its concreting in 2007. The bottom right image presents Rosses Points' current rock armouring and new concrete ramp extending from Bromore Point 400m North. The image was taken during high tide on 21/02/22 at 10:36.

*Figure 3: Top left: Oblique imagery (2003) of rock armouring and beach access ramp at Strandhill at low-tide, Top right: Present rock armouring and access ramp at Strandhill, Bottom left: Oblique imagery (2003) of unarmoured Bromore point at Rosses Point and Bot*

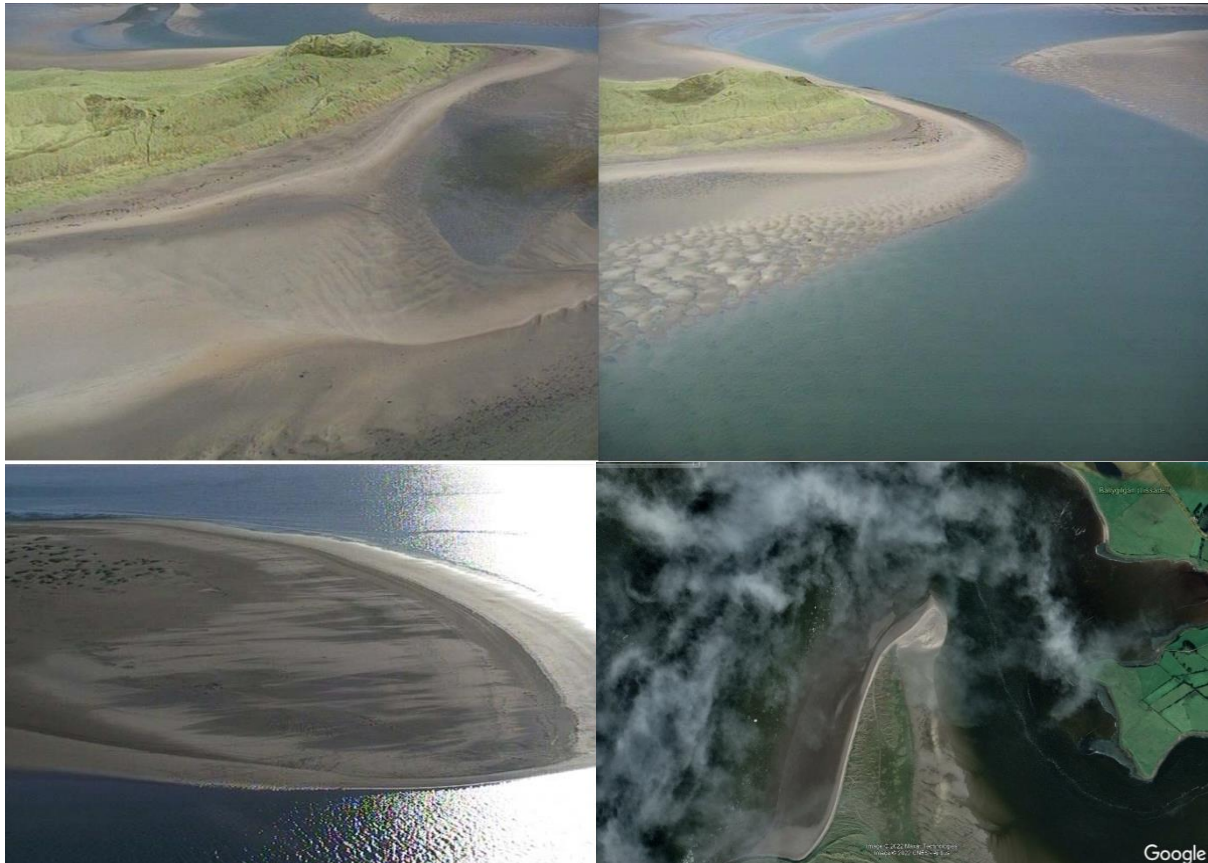
Figure 4 shows the geomorphological features at the study sites which were recorded during the Oblique imagery survey (2003). The top left image shows the Strandhill beach sand spit which southernly extends from Strandhill town (figure 2). The top right image shows the Ballysodare estuary inlet which is enclosed by the Strandhill sand spit and the Portavade beach. The bottom left image presents the Sandspit north of Rosses Point lower (figure 2). Small embryonic dunes can be seen forming in figure 4. The bottom right image shows the sand spit north of Rosses Point with a strong dune system built upon it in Google Earth Pro as of 2/10/21.

*Figure 4: Oblique imagery (2003)- Top left: Strandhill beach sand spit, Top right: Ballysodare Estuary opening, Bottom left: Sand spit at Rosses Point Lower, Bottom right: Sand spit at Rosses Point from Google Earth Pro 2/10/21.*

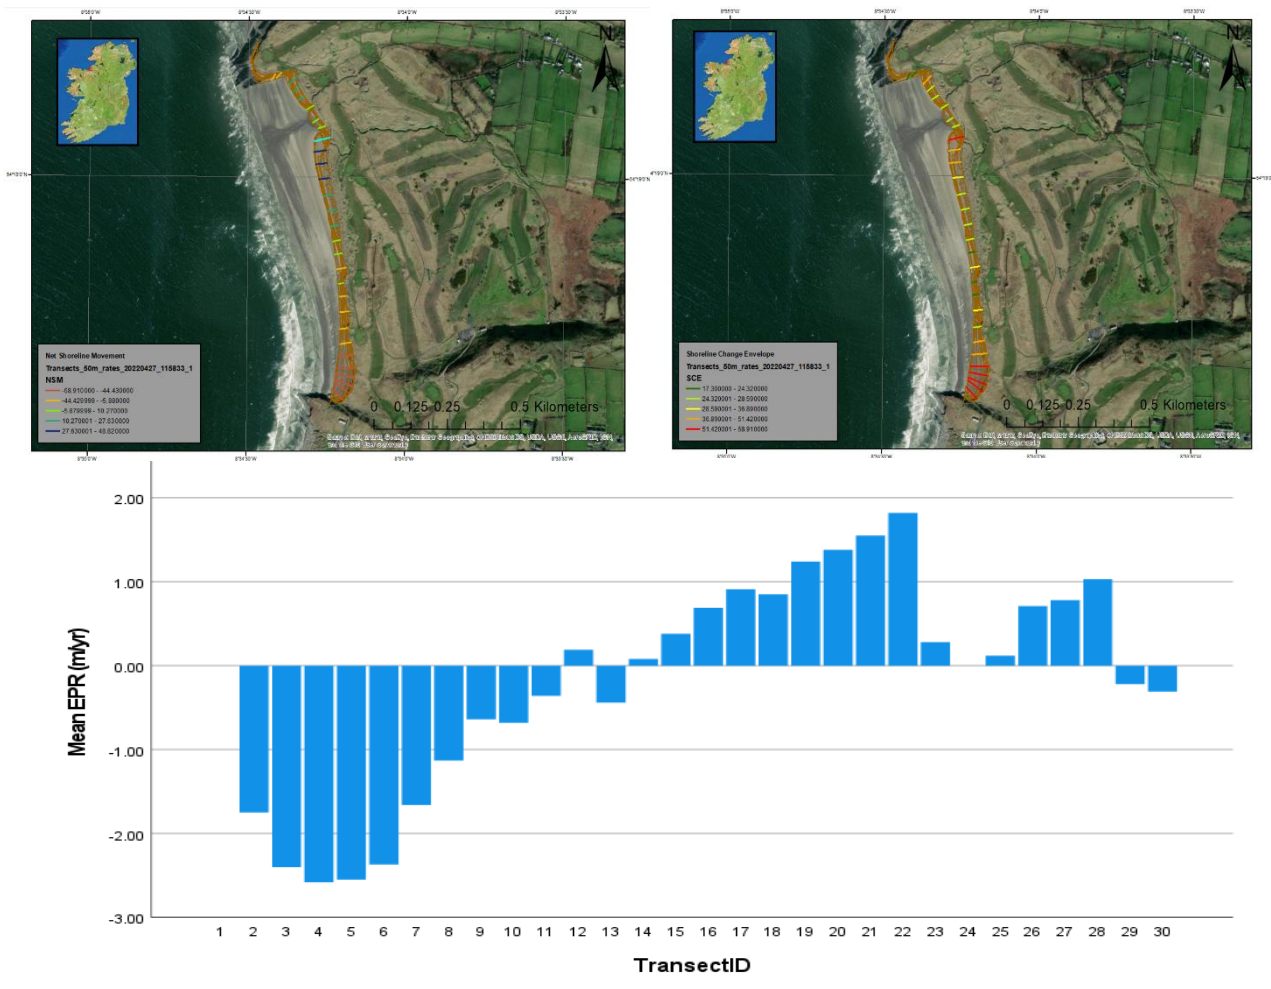
The SCE and NSM measure the distance of shoreline change at Rosses Point and are presented in an exported ArcMap in figure 5. The SCE shows that transects 2-6 and transect 22 experienced the largest rates of change along the shoreline. SCE always returns positive values and therefore other statistics must be relied upon for marking the change as accretion or erosion. Transect 4 experienced the largest rate of change being 68.91m.

NSM can return negative and positive values allowing distinction between accretion and erosion. Transects 2-7 returned the largest erosion values. Transect 4 displayed the largest record of erosion of -68.9m. Transects 18-21 returned the largest records of accretion. Transect 22 returned the largest accretion value of 48.82m. The results of the NSM show an average erosion of -4.5143m across all transects at Rosses Point (table 2).

Figure 5: DSAS rate of change statistics of Rosses Point, Top left- Net Shoreline Movement, Top right- Shoreline Change envelope, Bottom- End Point Rate.

The EPR is presented graphically in figure 5 for Rosses Point. The rate of shoreline change is calculated by dividing the distance of shoreline displacement in meters by the elapsed time between each shoreline's date recorded (years) (Thieler et al., 2009). The mean EPR

calculated for Rosses Point is  $-0.1693\text{m/yr}$ . The lowest result calculated was  $-2.58\text{m/yr}$  at transect 4 and the highest calculated was  $1.82\text{m/yr}$  at transect 22 (table 1).

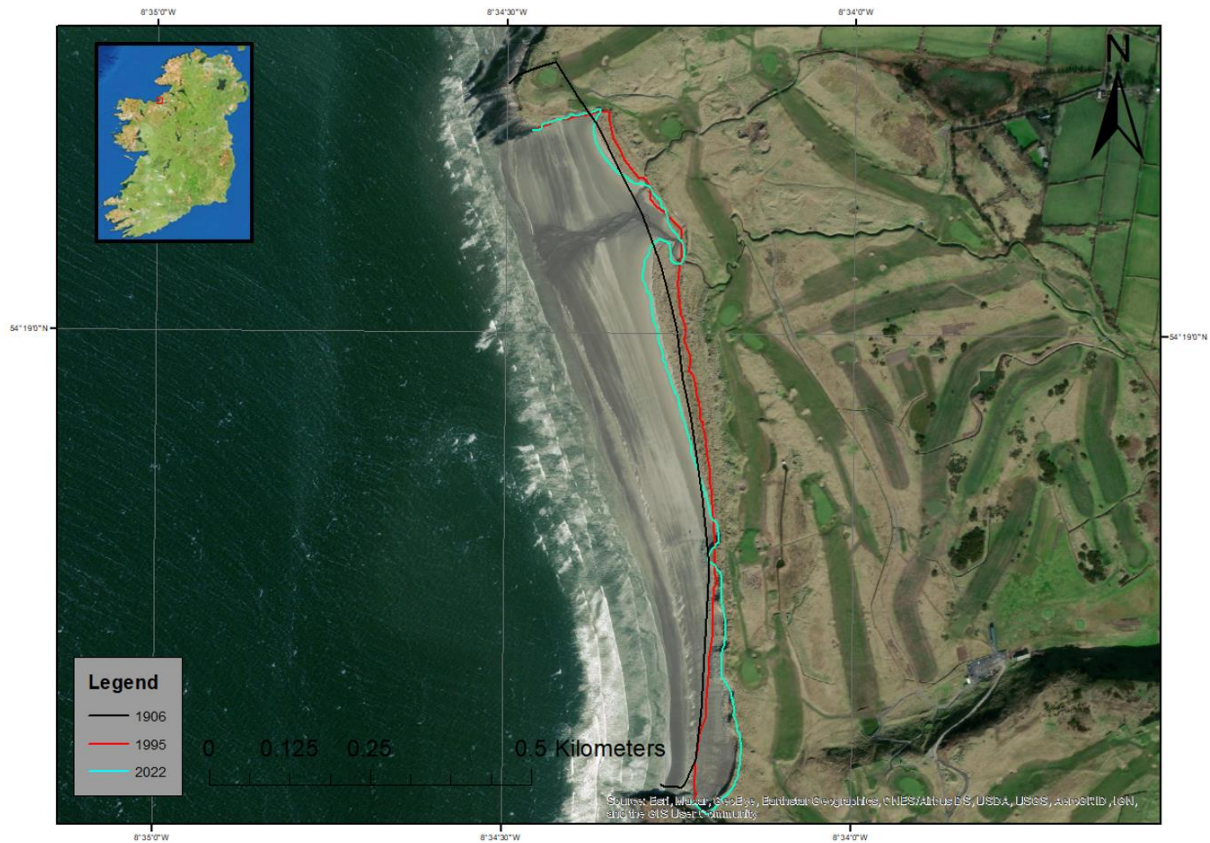
Figure 7 shows the historic shoreline of Rosses Point beach digitised in ArcMap compared with the 1995 digitised shoreline and the GPS shoreline recorded on 19/02/2022. Historic maps are not accurate enough to be processed in ArcMap as they are hand-drawn and do not account for all coastal features as can be seen above where the small estuary at Rosses Point has no marking on the historic vegetation edge record. However, they can be presented for visual comparison.

Figure 7: Historic (1906), 1995 and Fieldwork (2022) Vegetation Edges for Rosses Point.

since 2014 as seen in table 3 reflecting that the coastal defence has altered the response of the coastline at this beachfront. Figure 7 reinforces the statistics as variation in shoreline from 1995 and the GPS recorded vegetation edge in 2022 show a low variation visually of the shoreline. It shows the accretion in the southern half of the beach and the erosion in the northern half from 1995 to the present day. The historic line however does not align with the northern headland of the beach showing the inaccuracy of using historical mapping for the rate of change statistics as it cannot be relied upon to be drawn accurately for measurements. Overall, Rosses Point beach shows that when a coastal zone is given tourism and economic importance over environmental natural stability coastal protection can be implemented to alter the response of the coastline in a way to stabilise the vegetation edge. As this study does not measure high-tide or low-tide marks for the shoreface it cannot conclude if the coastal defences have altered the cross-section of the beach or the sediment load of the beach. The site has maintained its coastal features such as the sand spit north of the beach (figure 4) which has seen little movement and the embryonic dunes have slowly built up since 2003. The northern estuary has maintained a strong presence also.

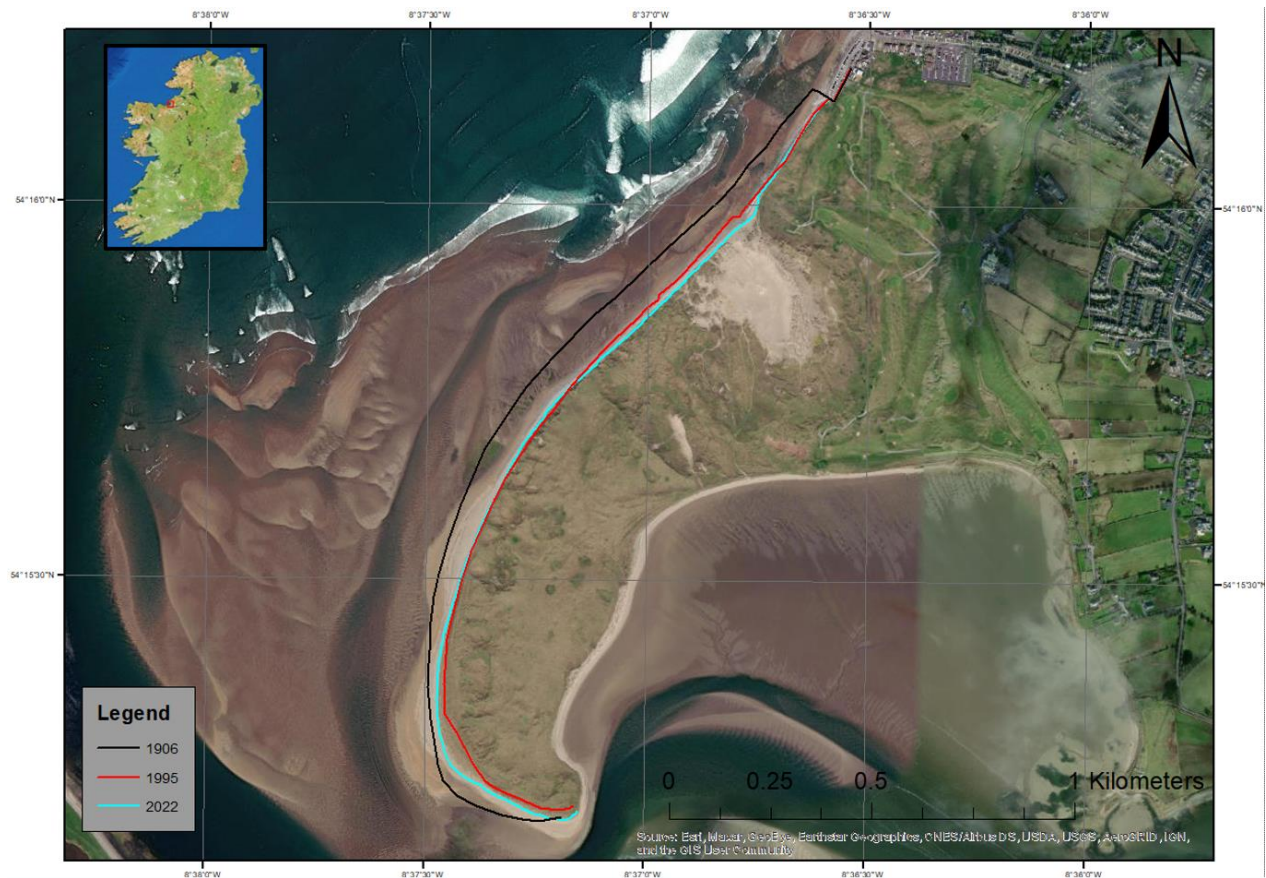
Figure 10 presents the historic shoreline position from the 1906 GeoHive map compared to the earliest recorded shoreline position from DSAS (1995), and the GPS recorded vegetation edge from 17/02/2022. This shows a gentle erosion since 1906.

Figure 10: Historic (1906), 1995 and Fieldwork (2022) Vegetation Edges for Rosses Point.

in 2003 could be noted as affecting stabilising the system as the transects (figure 9) all noted an erosion in position from the 1995 imagery (figure 10) compared to the 2000 imagery. After this, the fixed dune-backed portions of the vegetation edge accreted and stabilised from 2005 to 2014.
